NASA TECHNICAL MEMORANDUM

NASA TM-78201

ARC TERMINATION CRACKS IN INCONEL 718 AND INCOLOY 903

October 1978

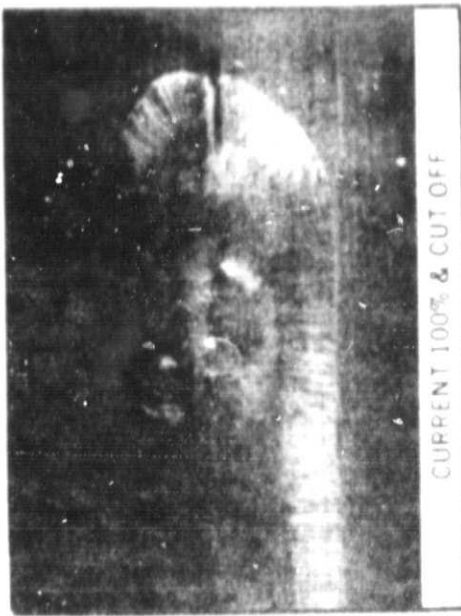
Eight root pass weld beads were made manually with the weld current terminated as rapidly as possible. This technique would simulate an unplanned termination such as loss of power or malfunction of equipment. Seven were similarly made by machine weld operations. All 15 weld terminations had crater cracks and most were very deep, some completely through the weld nugget. A typical termination is shown in Figure 2.

CURRENT 100% & CUT OFF

AUTOMATIC OPERATION

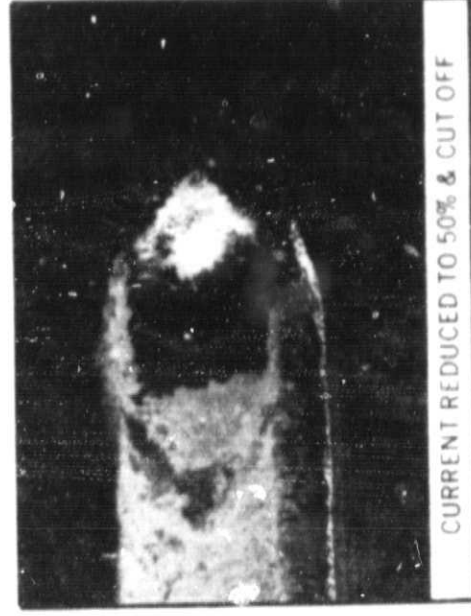
Approximately 16 terminations, eight manual and eight machine welded, were made by reducing the weld current to 50 percent of its normal value before cutoff. Investigation of this technique provided a better understanding of the crater crack causes, although it probably would not be used in production. Using this technique, the crack sizes at termination were smaller and in 50 percent of the cases were either too small to be detectable, or were nonexistent, as indicated by nondestructive testing. Termination cracks were detected in the other 50 percent of the terminations. Typical terminations are shown in Figure 2. Variation in cracks appeared to be related to travel speed and wire rate addition during the "tail out" modes.

CURRENT REDUCED TO 50% & CUT OFF

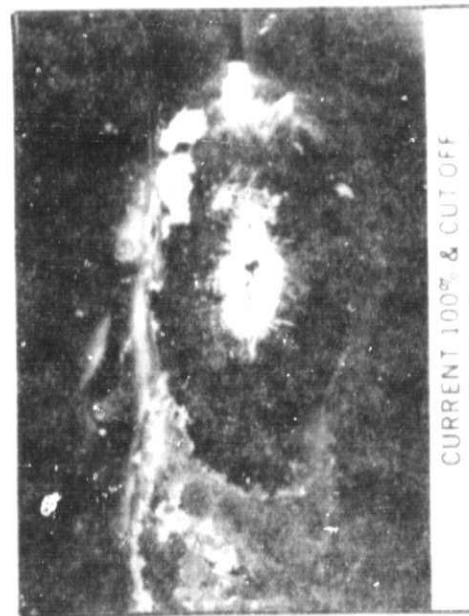
CURRENT 100% & CUT OFF

MANUAL OPERATION

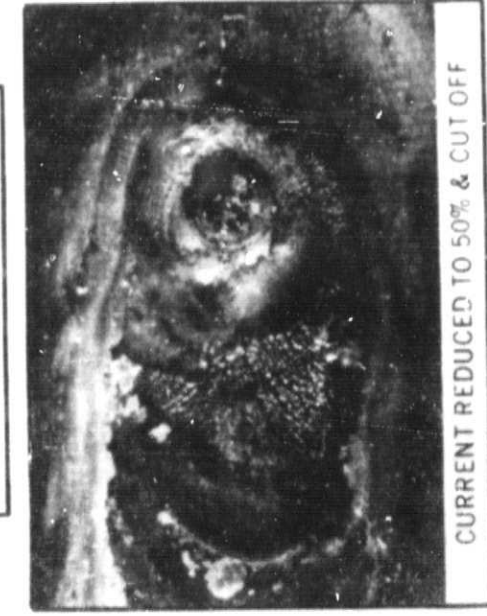
CURRENT REDUCED TO 50% & CUT OFF

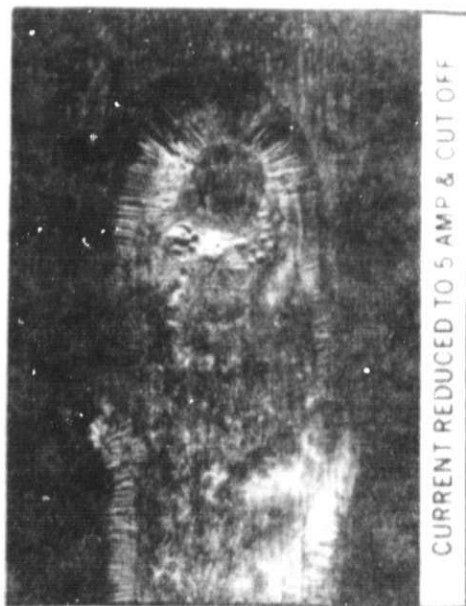
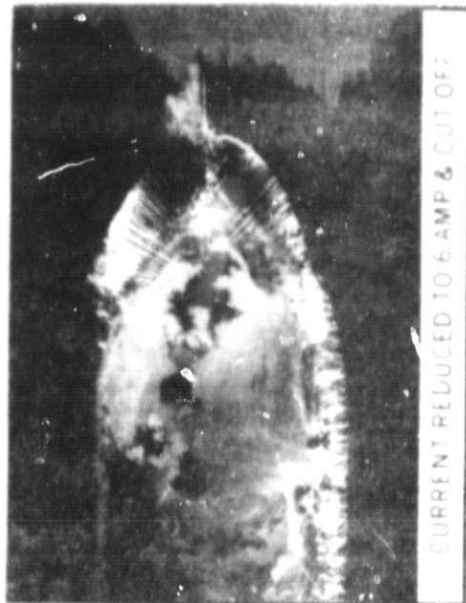
Figure 3. Weld termination in 0.250 in. Inconel 718.

process. Two of eight terminations resulted in crater cracks in the manual welds, probably a result of the lack of control as compared to an automatic weld.

All welds were examined visually, radiographically, and by dye penetrant. A typical termination zone produced by this reduced current technique is shown in Figure 3.

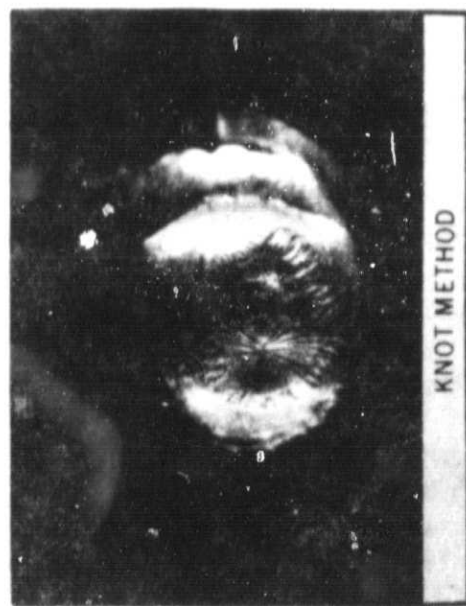
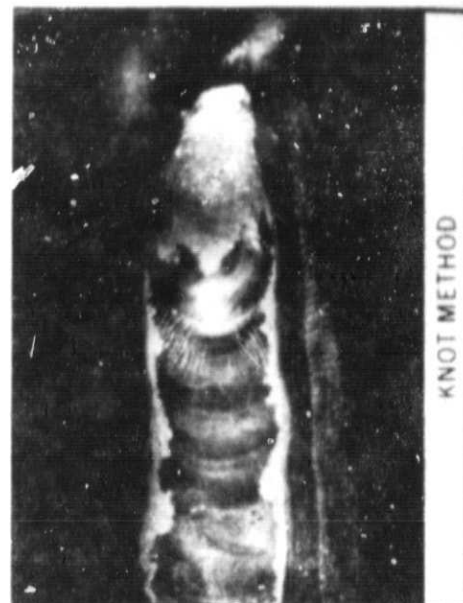
KNOT METHOD

This phase was an investigation of weld termination buildup techniques. Eight terminations (weld buildups) were made manually and eight by machine welding. The buildup technique required a weld movement dwell and buildup by wire addition while the current was uniformly reduced to approximately 5 - 6 A. This requires precise control of current, wire feed rate, and arc voltage during weld termination. Wire is added and a low current arc continued to maintain a slow cooling weld puddle. As the current decreases, the wire addition is reduced proportionately and the buildup is created. All test weld terminations of this type were crack free. All buildups showed various degrees of surface crazing as shown in Figure 3. This technique normally requires mechanical removal of the buildup before subsequent weld passes are made.

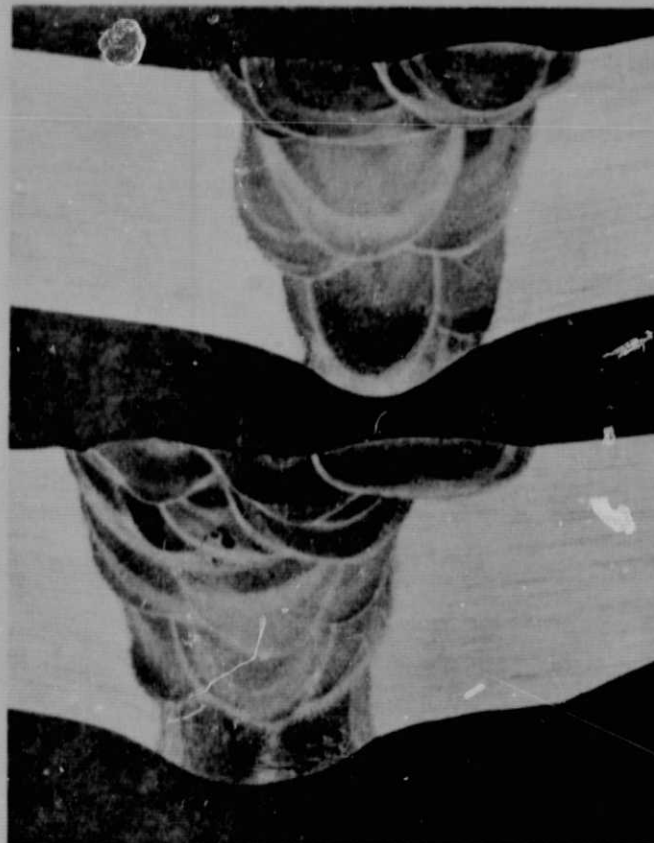
Figure 4. Sections of weld panels 14M (top) and 15M (5X).

In this phase, multipass welds were made over known crater cracks, crater cracks that had been revealed by dye penetrant inspection, and crater cracks that were mechanically ground, chemically etched, and examined with dye penetrant. Three welds were made by each technique, manual and machine welded. In all cases, there were no detectable cracks in the completed welds; however, porosity and oxide inclusions were noted.

Figure 4 shows a cross section of a weld over a crater crack in panels 14M and 15M. The crater cracks were in the penetration pass. Panel 15M shows defects that were found to be a combination of gas porosity and oxide contamination. Figure 5 shows the defects in panel 15M at 50X. The defect near the penetration side of the weld possibly is a result of welding over entrapped dye penetrant.

The practice of welding over cracks is not recommended because of the possibility of not refusing the crack and the likelihood of having porosity and oxide inclusions. When a crack is detected the best practice is to remove the crack mechanically, etch the area, and dye penetrant examine for assurance of removal.

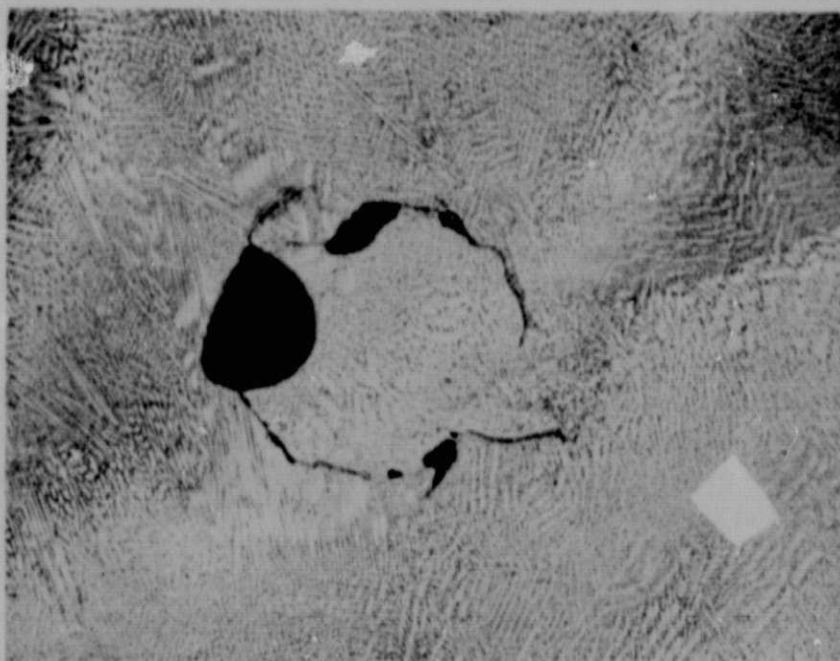
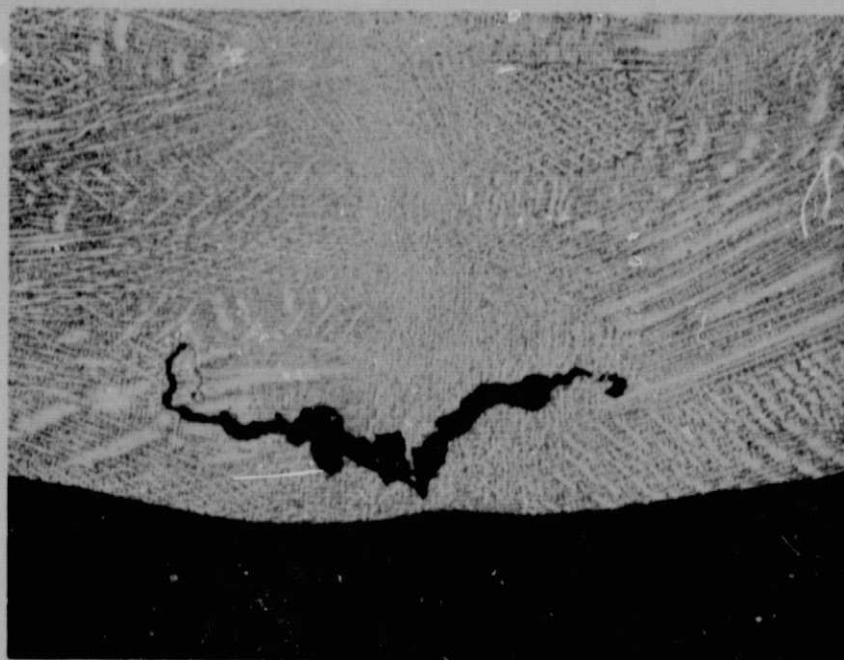
Figure 5. Defects in 15M (50X).

Weld 15M.

Root pass of weld 15M.

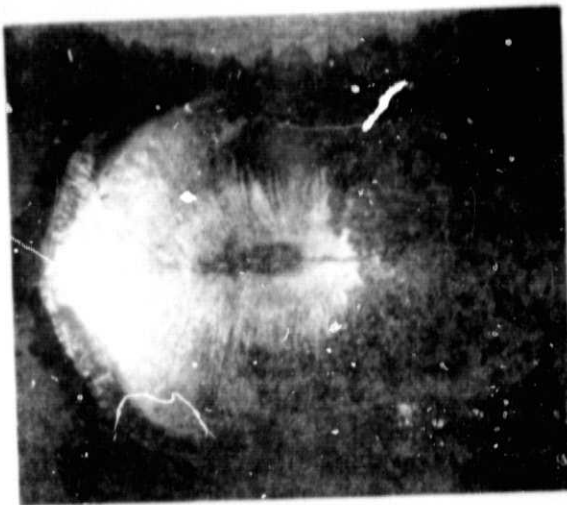
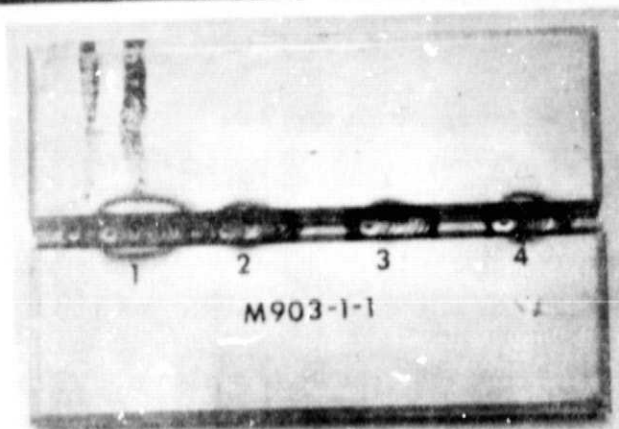
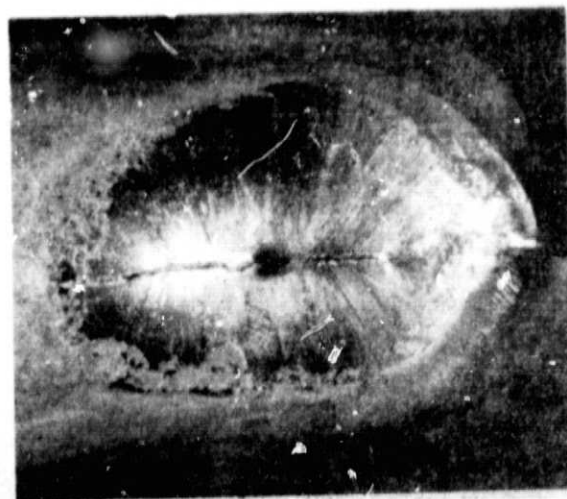
Figure 6. Panel M903-1-1 (welding A 70 and termination A 70).

This phase involved a determination of the crater cracking sensitivity of Incoloy 903 as compared to Inconel 718. Arc terminations were made by arc shutoff at welding current. These also resulted in crater cracks in 100 percent of the terminations. Utilizing the weld buildup technique used on Inconel 718 eliminated the crater cracks in Incoloy 903. Figure 6 shows the defects resulting when the arc is terminated at welding current, and Figure 7 shows the defect free weld buildup technique. The limited amount of investigation on Incoloy 903 did not give us a relative comparison of the crater crack sensitivity of Incoloy 903 and Inconel 718.
